**OH&S Fatality Accident Report
Holcim Bétons France - Dijon Béton
Saint Apollinaire - September 14th 2010**

**Report to Holcim Ltd Executive Committee
303rd EXCO Meeting, Agenda Item # 19**

Incident Summary

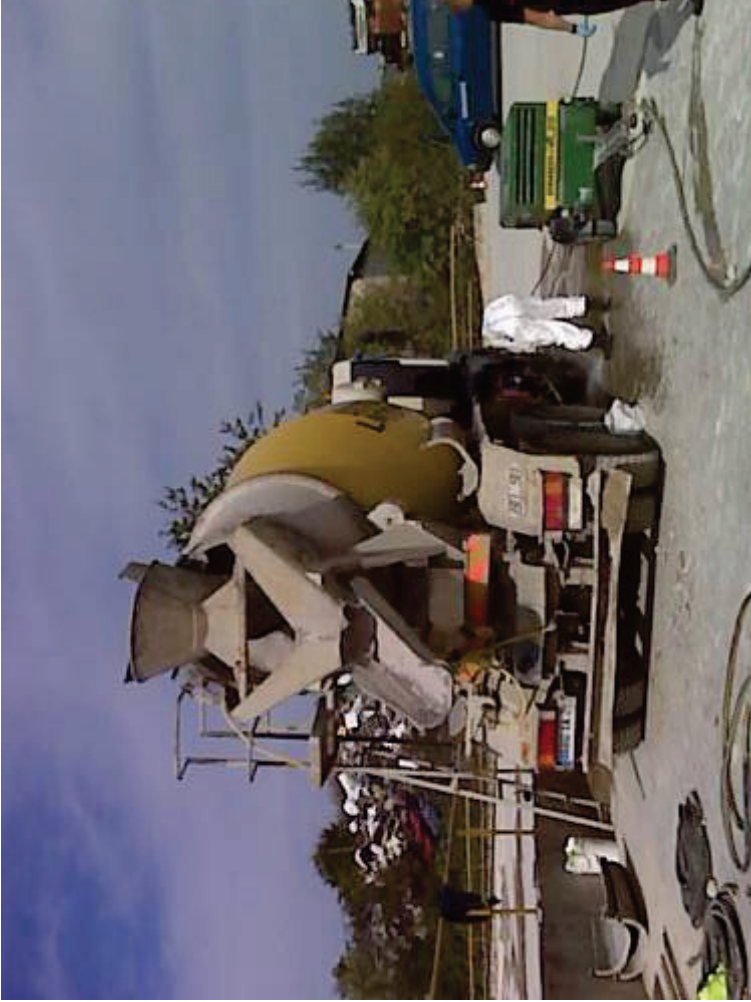
- To start “chipping”, the driver put the drum in the required position and then turned off the engine, keeping the ignition key in his pocket, in accordance with procedure at Dijon Béton.
- The drum was not locked by mechanical means, (in accordance with the procedure)
- For some reason which is still unknown, the victim had the upper part of his body in the manhole.
- The victim was stuck between the drum’s châssis and the top edge of the manhole, as the drum was slowly and imperceptibly turning due to imbalance.

Picture of the truck just after the accident

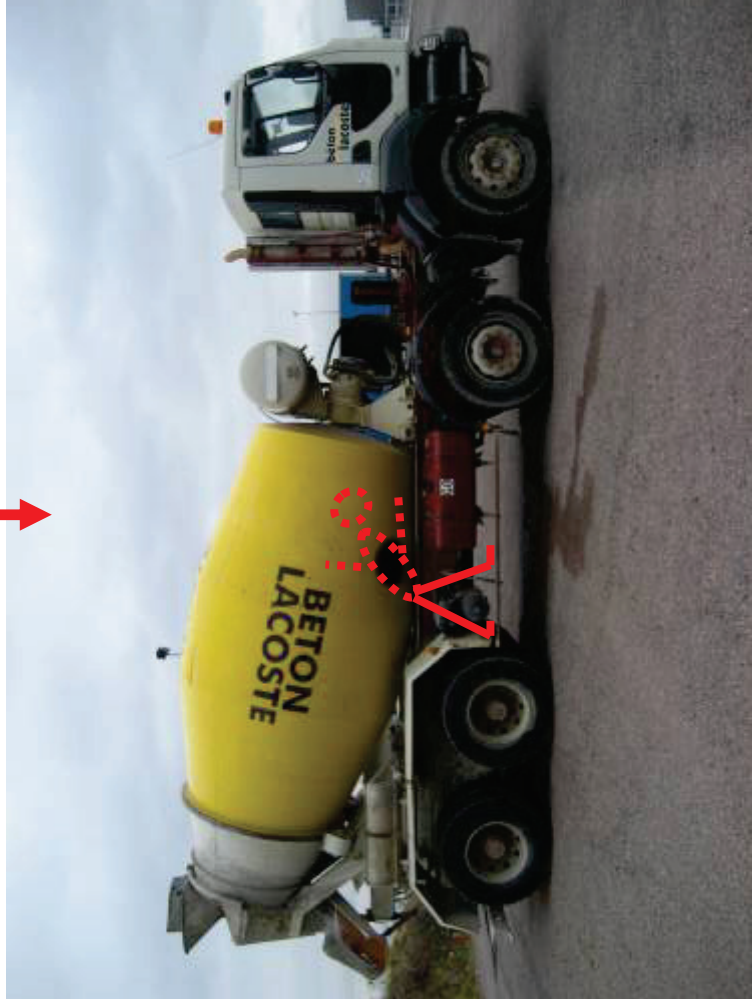
- The victim called for help.
- A worker arrived on the scene and saw the victim stuck in the manhole. He called to the driver who was on the platform on top of the truck at the time, to come down, restart it and to operate the levers to bring the manhole back up slowly so that the victim could be freed.
- The driver started the truck again, then operated the lever to rotate the drum, unfortunately in the wrong direction.
- The victim's body was severed.

Picture of the truck with the manhole open and with the assumed position of the victim

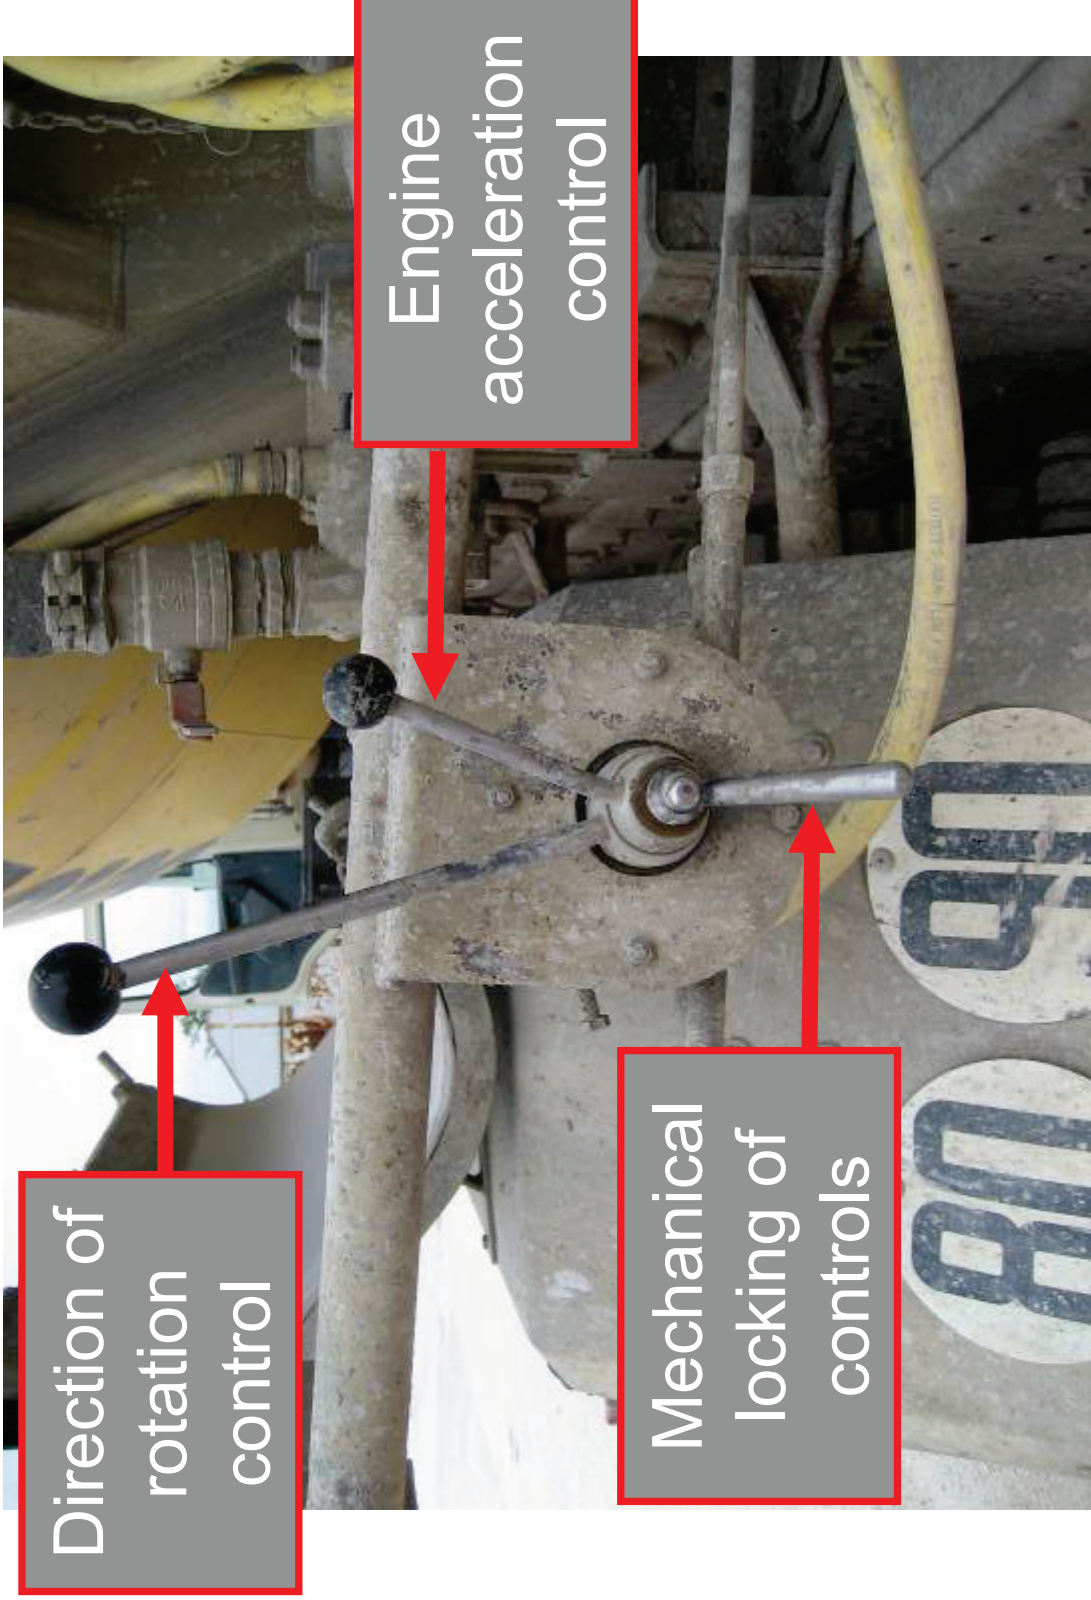
Photos of the controls (rear left of truck)
